## SAW CREEK CLUB DAM

NDI ID NO. PA-00764  
DER ID NO. 52-7

### PHASE I INSPECTION REPORT NATIONAL DAM INSPECTION PROGRAM

FEBRUARY 1980

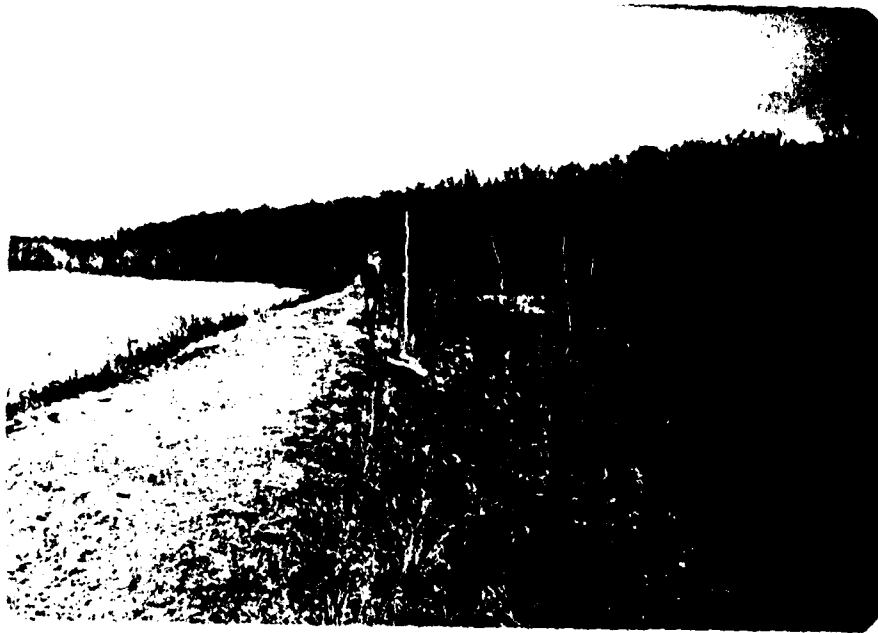
b. Embankment. The riprap on the upstream slope is in good condition. There is high grass and very low brush growing in the upstream slope (Photograph B). The downstream slope is slightly uneven. It has low brush and a few small trees growing on it (Photograph C). The brush is significantly thicker to the right of the outlet works, near the right abutment (Photograph I). To the left of the outlet works, the downstream toe is protected by large boulders. The boulders also act as the right bank of the spillway exit channel (Photograph A).

A. Downstream Slope

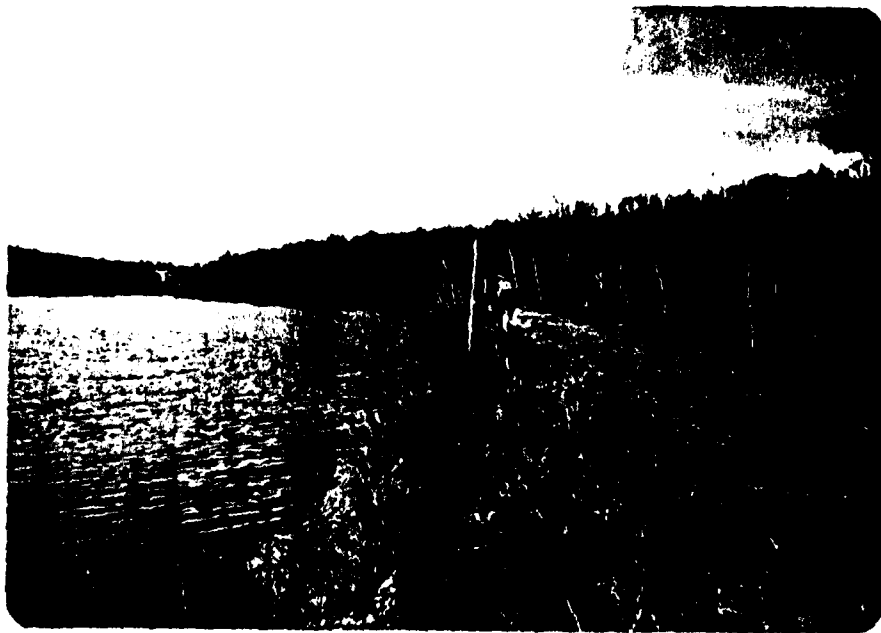
B. Upstream Slope

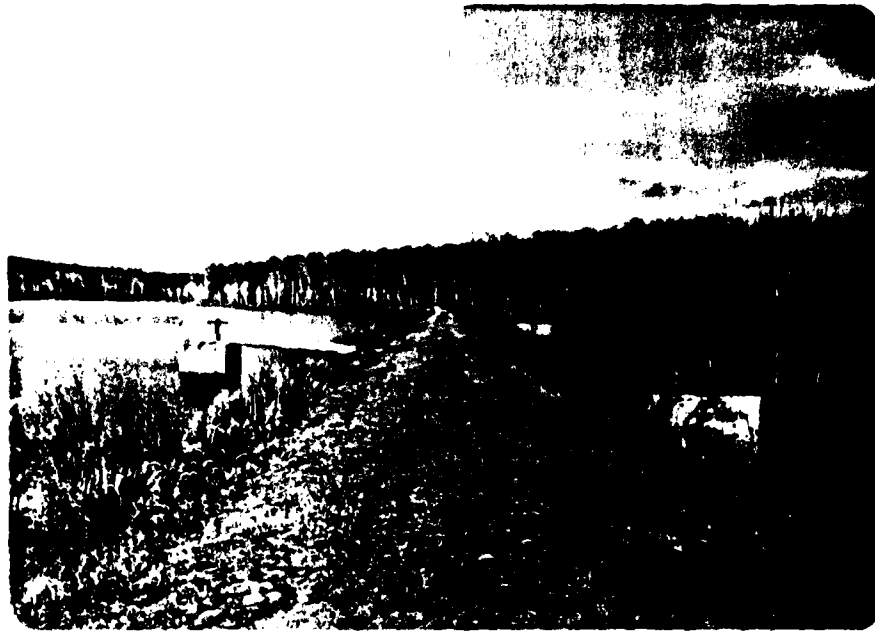
C. Top of Dam and Outlet Works

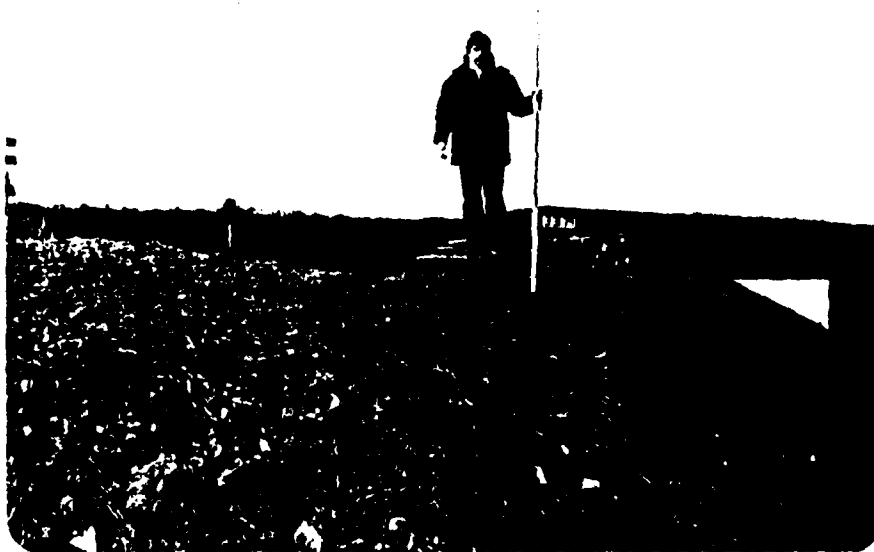
E. Low Area Near Spillway

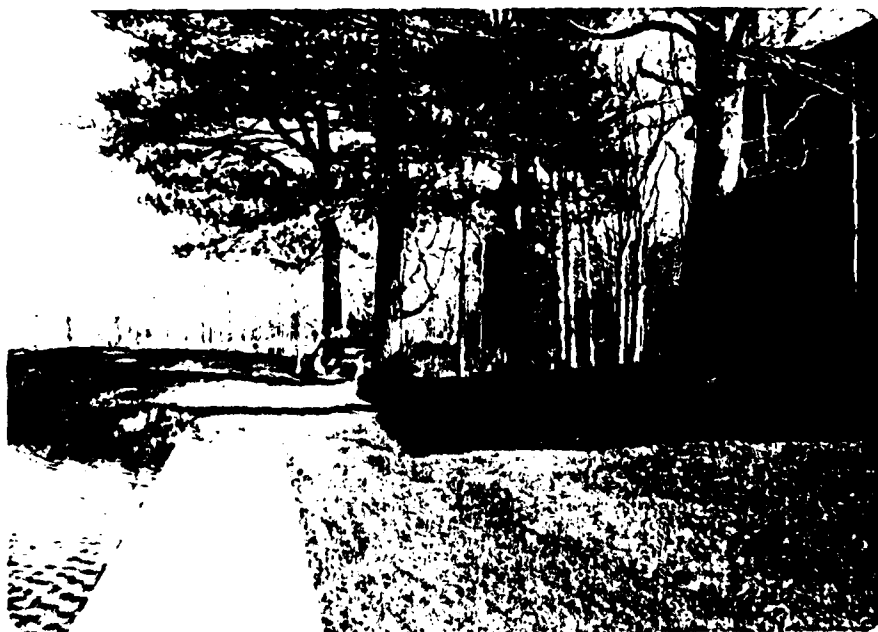
F. Low Area at Right Abutment

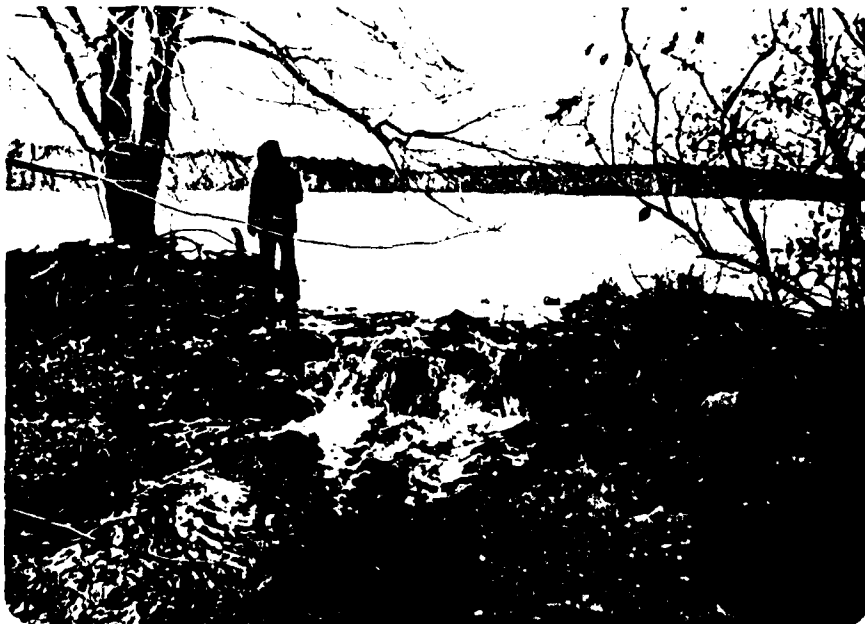
J. Twelvemile Pond - Upstream of Saw Creek Club Dam
